## Case History

### 1725 - Mine Water Tank

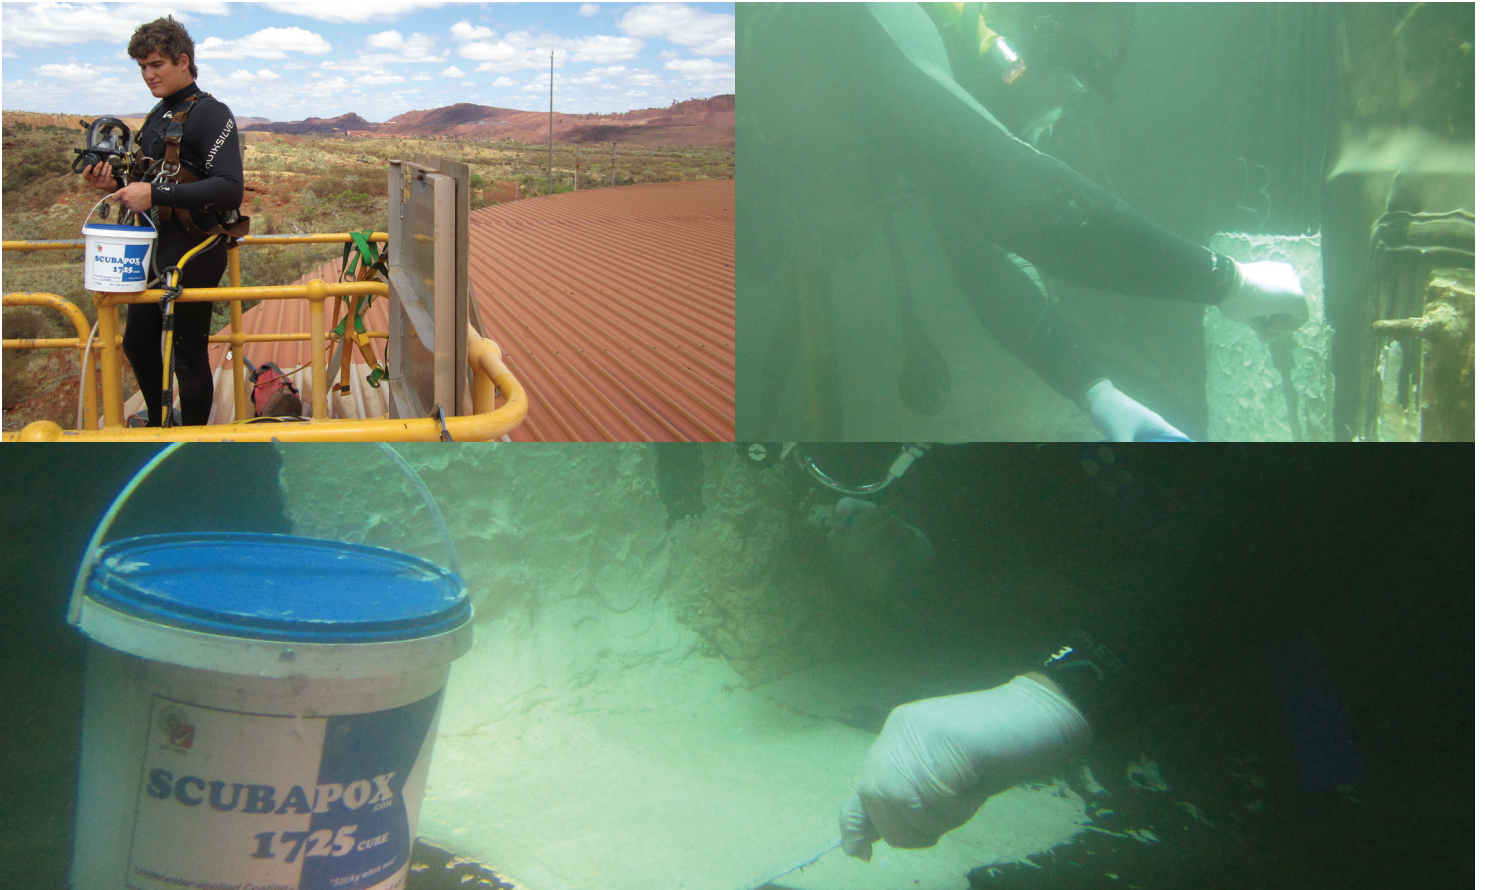
A very large mining industry client in the northwest of Western Australia had multiple leaks in one of their main water tanks. The massive 60m diameter x 15m high tank had previously been lined with High Density Polyethylene (HDPE), but the seams were now splitting apart and had the potential to undermine the tank, resulting in the earthen base subsiding.

Fremantle Diving Centre used 150 litres of 1725 underwater to seal all the leaking seams and apply a reinforcement material to prevent them from splitting in the future. The project was completed on time with the tank fully repaired and 100% dry.
