SCUBAPOXY 5335

Flexible Underwater-applied Sealant

Case History

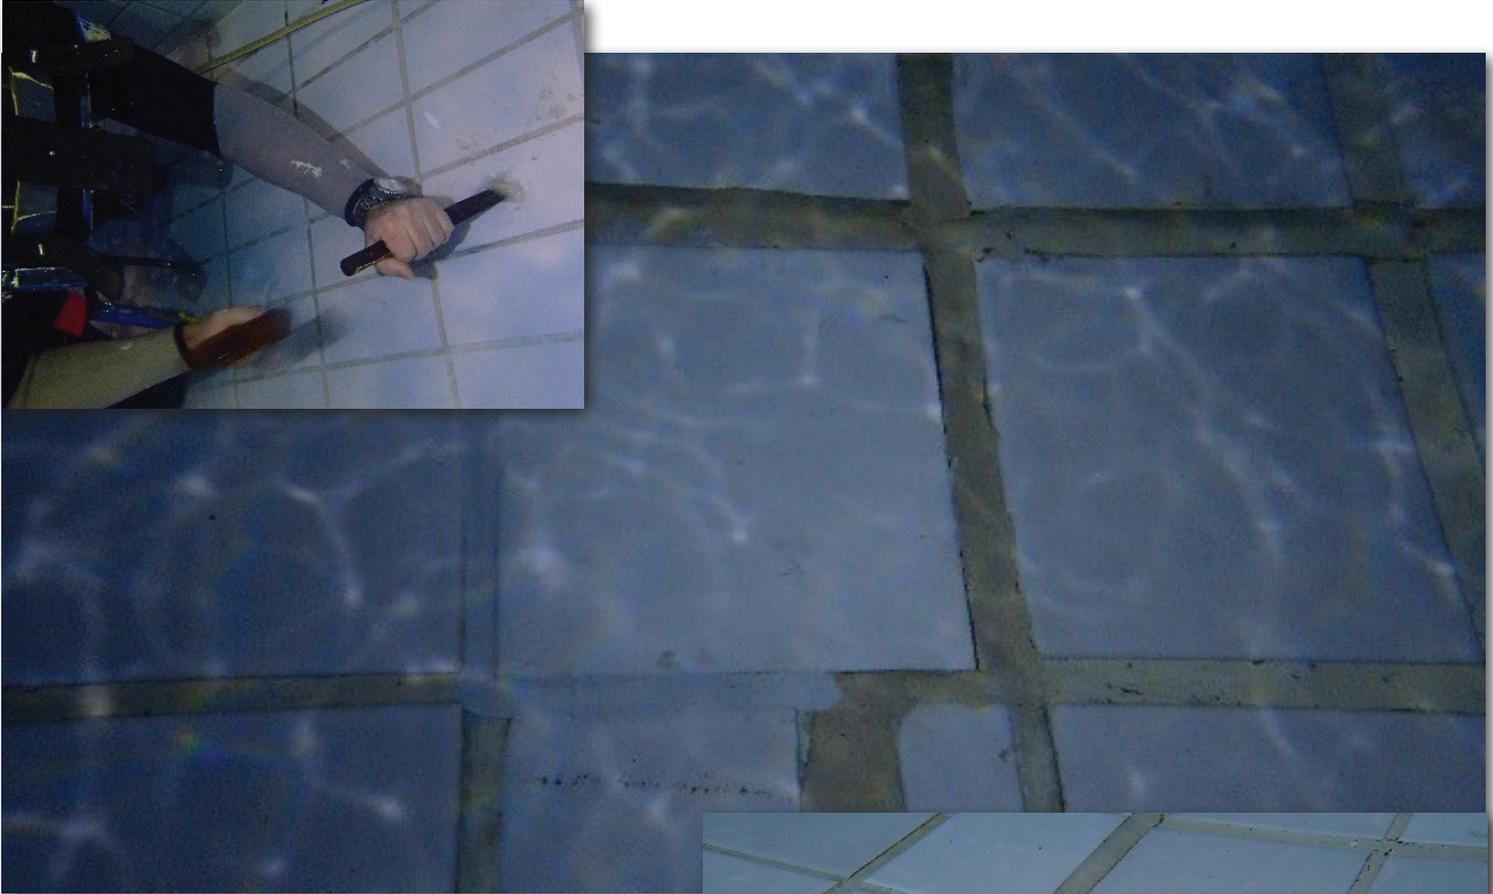
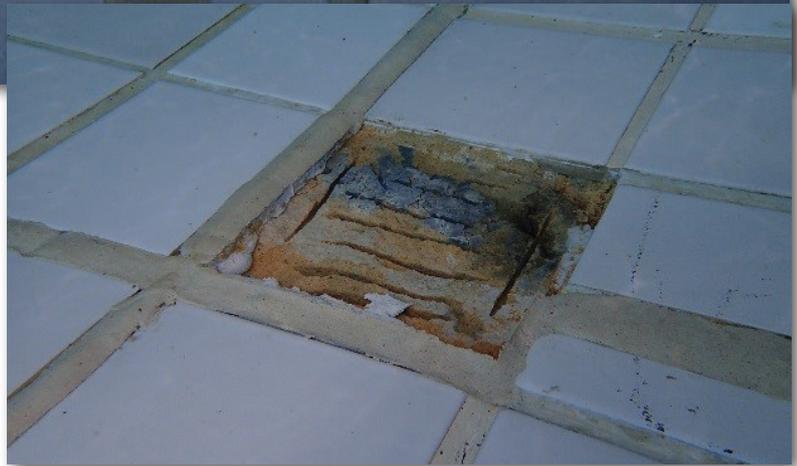
- A 50-metre pool in a swimming centre needed some extensive maintenance work after a survey conducted by a professional diving company. In addition to major expansion joint repairs, the survey also identified a number of tiles that were damaged or loose and needed to be replaced.
- Five tiles were replaced and re-grouted using Scubapoxy 5335 as part of the original scope of works, which included 4 white biscuit tiles and one black lane marker tile. In addition to those, several other tiles were identified as needing replacement while work was being carried out - some in a junction box in the deeper end, and others on a section of backing tiles located near the diving platform.
- The resulting repairs achieved a good result aesthetically, were solid, and solved a few OH&S issues in the process.
