## The Five Rs Retail Project Review

*Brought to you by Resin Flooring International*

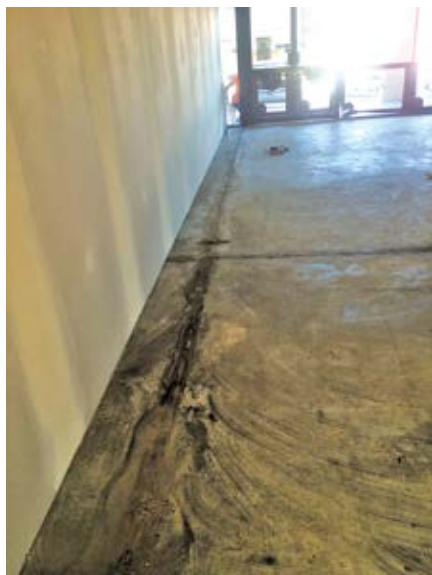
**Above::** Expansion Joint

Additionally, there was a large expansion joint running from the back of the store to the front that was problematic from an aesthetic point of view. Although the temptation was to cover it over, the anticipated structural movement of the concrete slab made it necessary to retain and repairs were made to the damaged edges to make it strong, neat, and tidy.

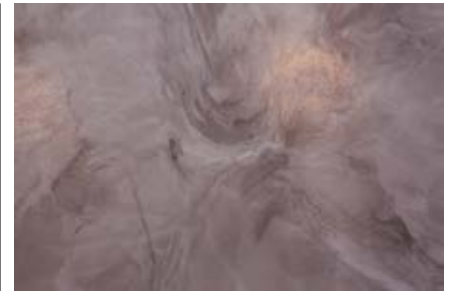
In the end, the system created was a custom metallic floor in the brand colours of the franchise, consisting of a coloured basecoat, marbled metallic topcoat, and a final clear epoxy topcoat with stir-in non-slip aggregate for better wear and slip resistance.

**Above::** Flooring Design

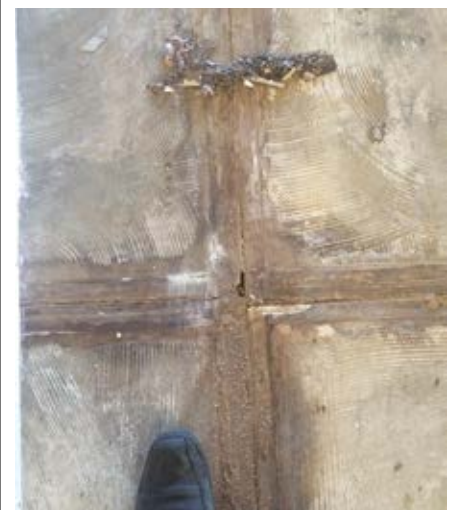
**Above::** Subfloor Glue

This retail floor was no exception as it threw up a few challenges that had to be resolved effectively. This included the removal of old glue from the previous floor covering that required specialist grinding equipment, and a saw-cut control joint running right through

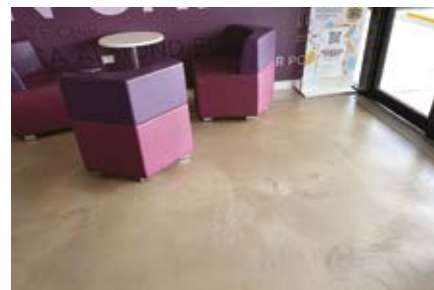
After almost ten years of daily use, a follow-up inspection of the store painted a very pleasing picture. The floor colour was still modern and there was no sign of wearing, fading or delamination of the epoxy system. The semi-gloss, slip-resistant floor finish showed minimal scuffing across the store and was able to be maintained easily by the staff. Even the expansion joint had held up remarkably well. By sticking to the Five Rs, a beautiful yet extremely functional custom flooring had been delivered and provided exceptional service to the clients over a long period of time. ▲

**Above::** 10 Year Service
